Oyster Bay / Cold Spring Harbor Watershed Action Plan

August 2011

FUSS & O'NEILL

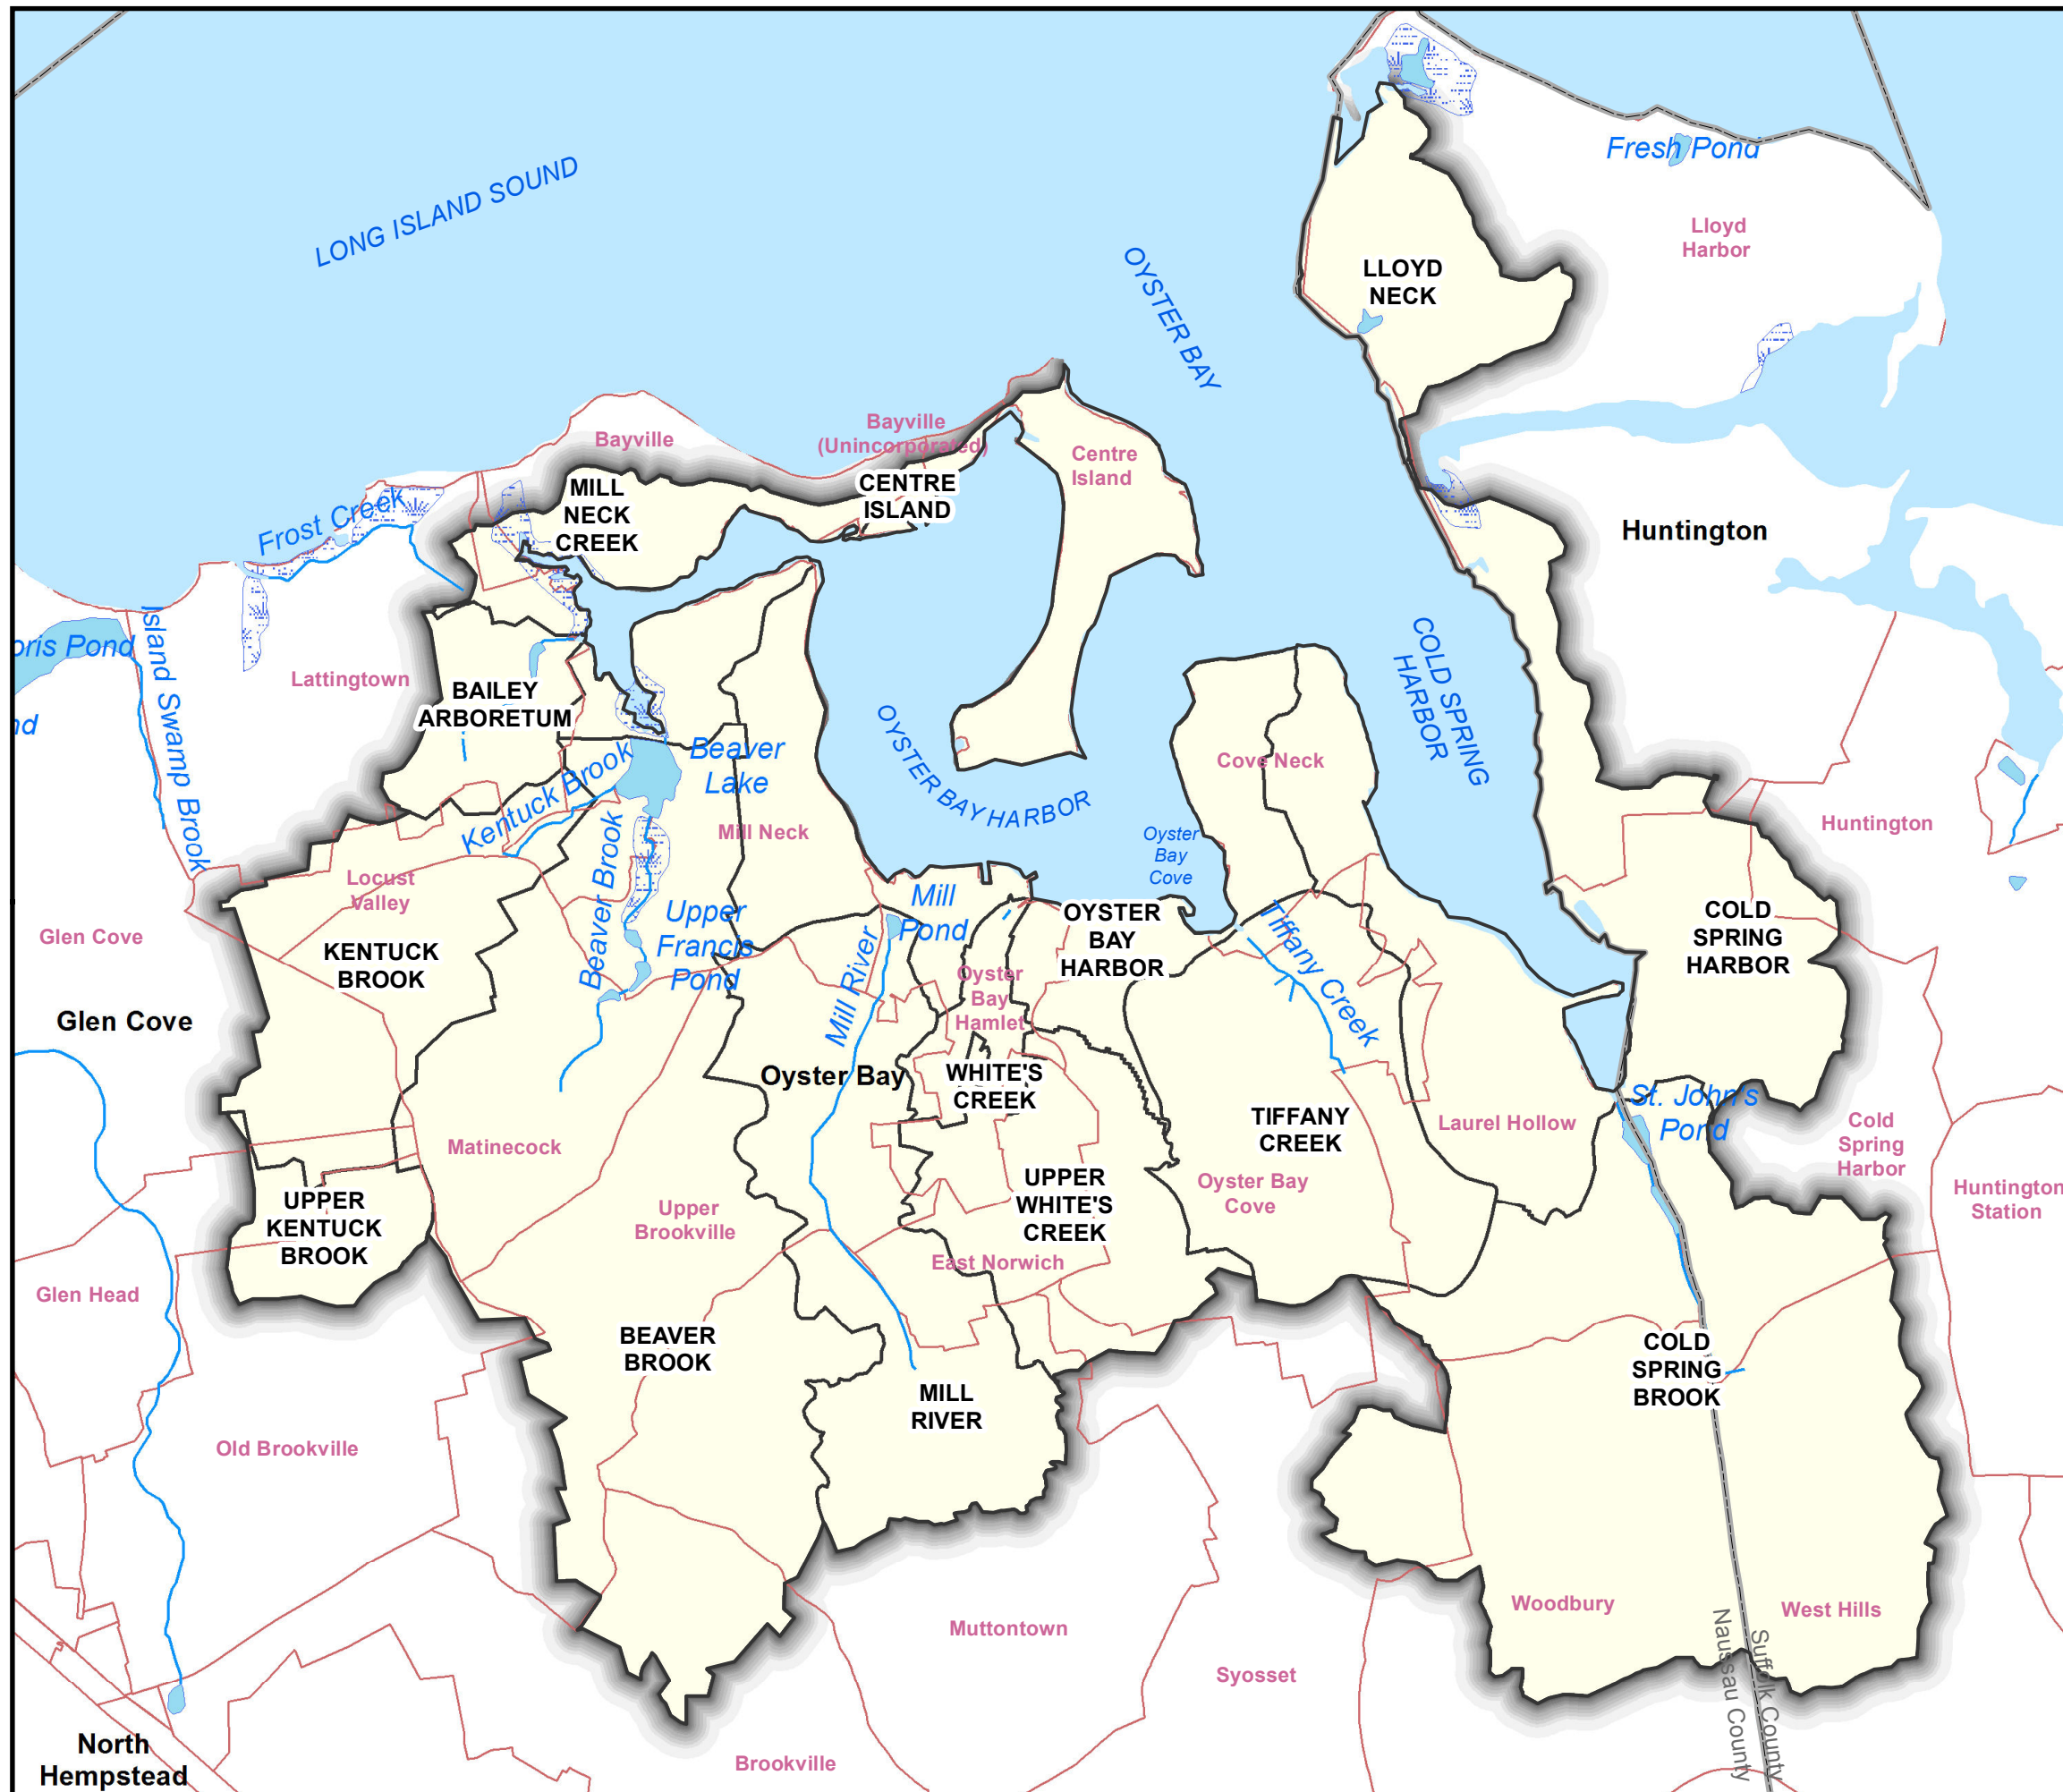
**Figure 1-1
Subwatersheds**

The harbor complex watershed is an approximately 39 square-mile area located in Nassau and Suffolk Counties. Approximately 80 percent of the watershed is located within the Town of Oyster Bay and its incorporated villages and unincorporated hamlets. A small portion (less than 2 percent) of the watershed is located in Glen Cove, also in Nassau County. The remaining 18 percent of the watershed is within the Town of Huntington and its incorporated villages in Suffolk County. The Oyster Bay/Cold Spring Harbor Complex watershed consists of 14 smaller subwatersheds, from which surface runoff potentially enters the estuary (*Figure 1-1*).

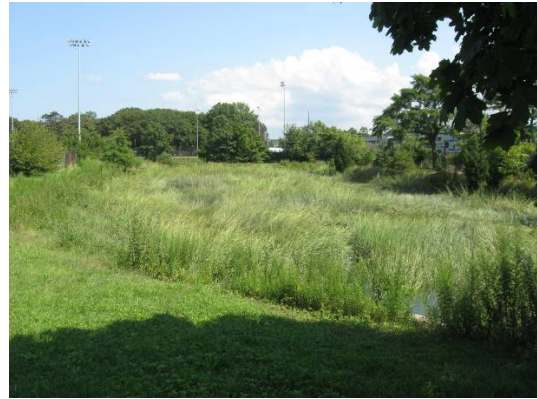
Several of the recharge basins maintained by Nassau County and the Town of Oyster Bay are overgrown and have large amounts of accumulated sediment and/or standing water, and a few are completely full. Although some of these deficiencies may be caused by high groundwater levels during all or part of the year, their performance may be compromised by accumulated sediment and reduced storage volume and infiltration capacity, which could potentially result in sediment resuspension and washout.

The counties and municipalities should review existing recharge basins to assess sediment accumulation, infiltration effectiveness, overflow mechanisms, and the need for maintenance and/or retrofit.

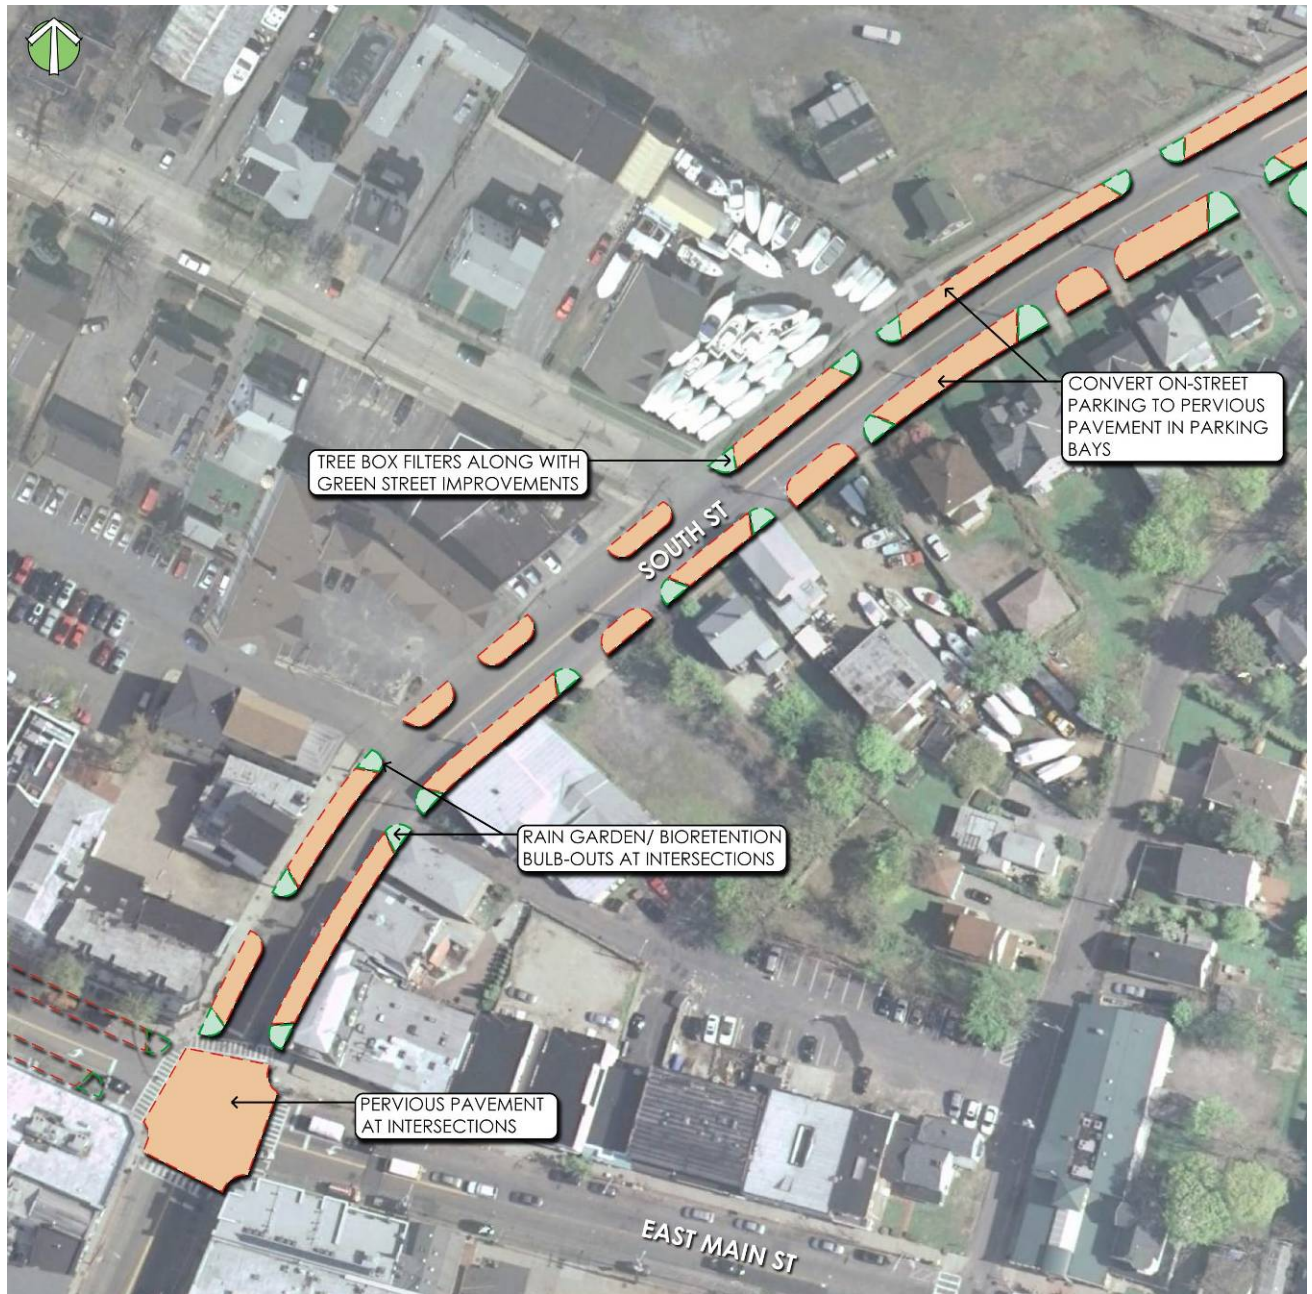
Figure 4-1. South Street Green Street Retrofit Concept Plan

A “green street” retrofit of South Street would address stormwater management and streetscape improvement objectives. One potential concept (*Figures 4-1 and 4-2*) consists of reducing the amount of effective impervious cover along South Street to reduce runoff volumes, pollutant loads, and peak flow rates, as well as infiltrating and treating stormwater through the use of other green infrastructure practices. This concept maintains on-street parking and integrates stormwater management and streetscape improvements using green infrastructure approaches.

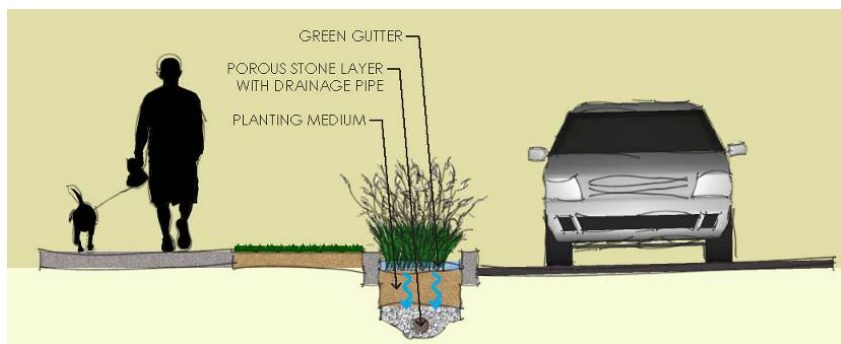
Figure 4-10. Typical Green Gutter Cross Section

Green gutters (*Figure 4-10*) help capture and slow stormwater runoff within very narrow and shallow landscaped areas in parking lots or along a street's edge. Green gutters are designed to be very shallow with little or no water retention. The primary purpose of using green gutters is to provide a site design measure using strip of landscaping to help filter out pollutants and slow the flow of water. If underlying soils are slow-draining, an underdrain can be installed below green gutters and other bioretention areas to convey filtered stormwater to the storm drainage system.

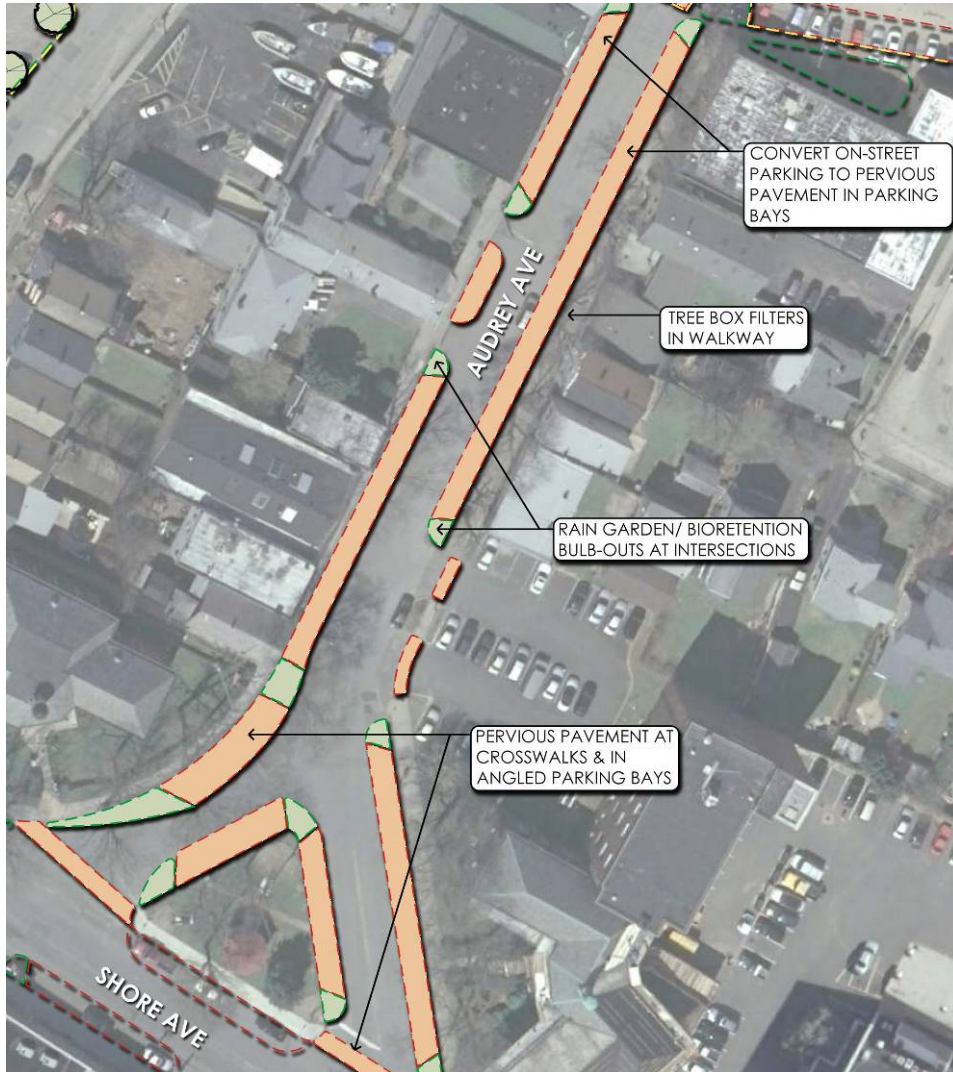
Figure 4-11. Green Street Retrofit Concept Plan for Audrey Avenue

The area surrounding Audrey Avenue and Shore Avenue in the Oyster Bay Hamlet is one of the busiest and most densely-developed areas in the watershed. The east-west segment of Audrey Avenue is heavily-traveled and closed every Tuesday evening during the summer for Cruise Night, a popular event where classic and unique cars are showcased. Audrey Avenue is lined with shade trees that are removed and replaced periodically to avoid interfering with the overhead utility lines along the street. This downtown district has high levels of impervious cover and on-street parking throughout. The concept developed for this area (*Figures 4-11 through 4-14*) would maintain on-street parking while reducing impervious cover and providing stormwater treatment.

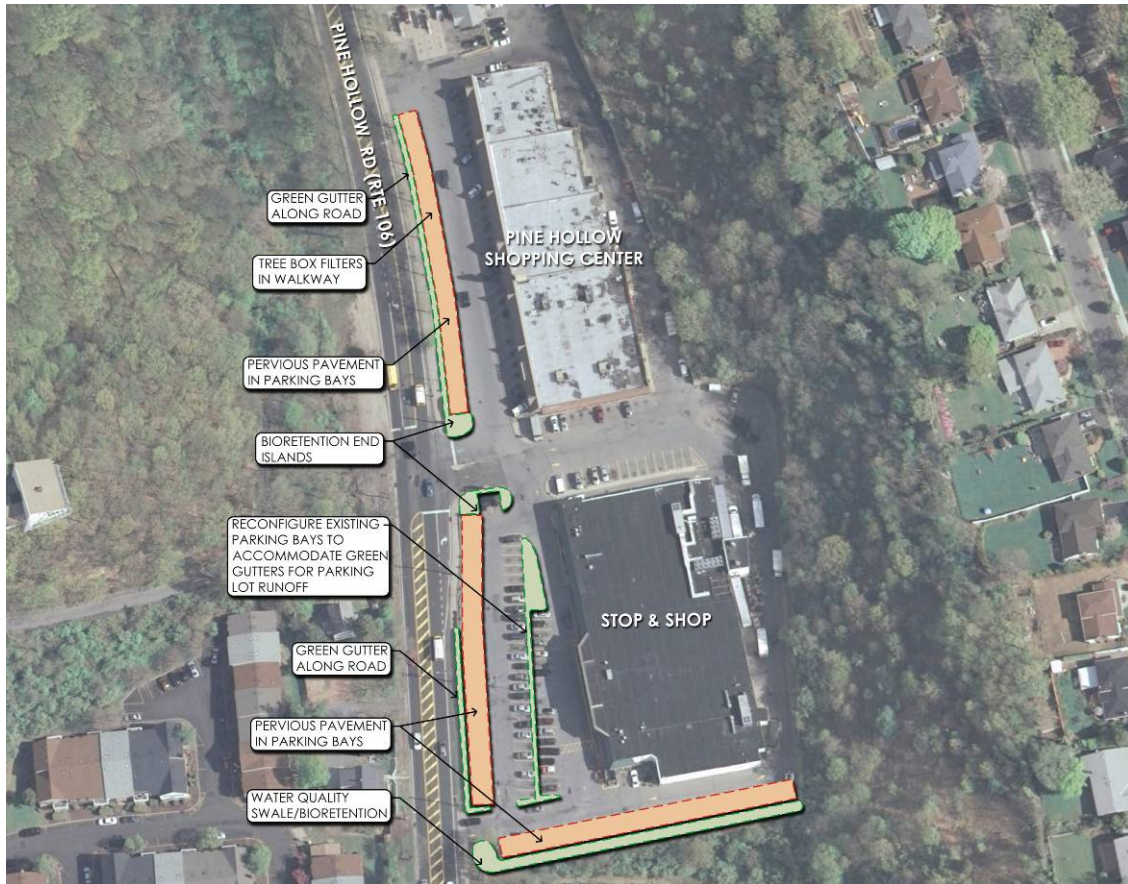
Figure 4-17. Retrofit Concept Plan for a Commercial Shopping Center

Green gutters and bioretention areas along parking stalls. The thin strip between the parking rows could be converted into a green gutter, and the wider island areas at the row ends could be converted to bioretention areas for stormwater treatment and infiltration. Trees could also be planted along the strip to increase shading of the parking lot.

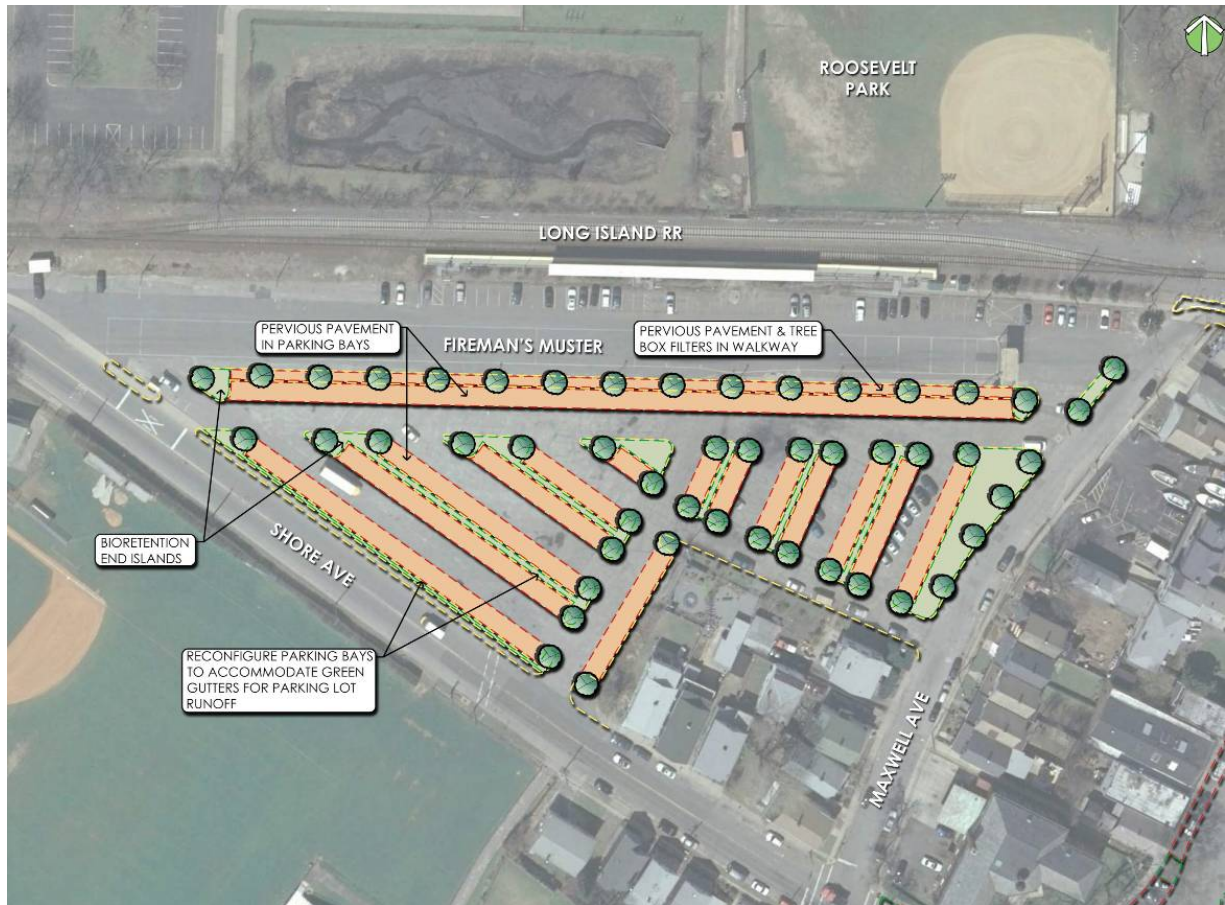
Figure 4-19. LID Retrofit Concept for Fireman's Field

Figure 4-19 expands on the existing proposed concept for Fireman's Field by incorporating additional LID stormwater management measures similar to those proposed for other concepts that are described in this section.

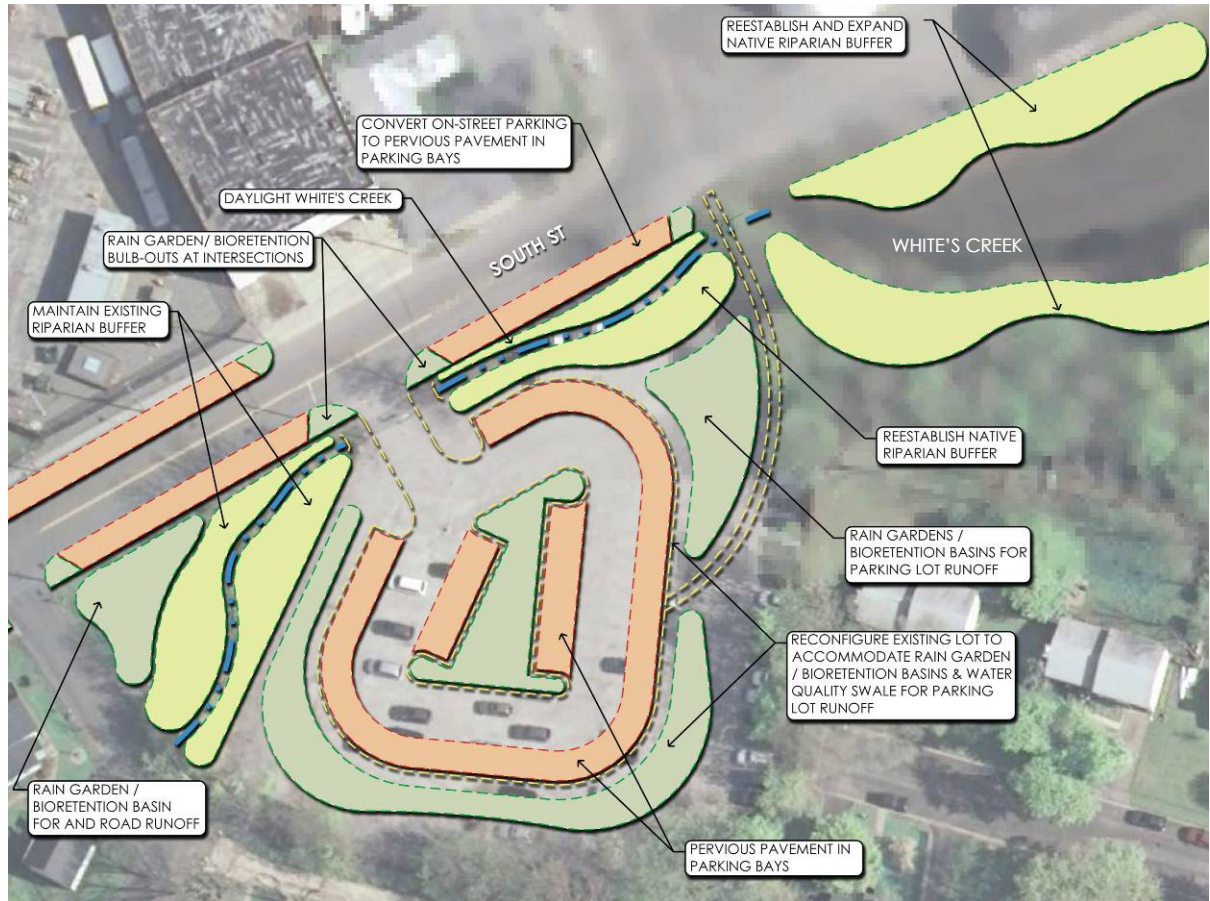
Figure 4-21. White's Creek Restoration Concept

Parking lot improvements. The existing parking lot could be retrofitted with pervious pavement and bioretention to capture, treat, and infiltrate stormwater. These improvements could effectively eliminate the stormwater contribution of this parking lot to White's Creek during most storms. A pedestrian walk and bridge over the daylighted White's Creek channel could also be incorporated into the design.

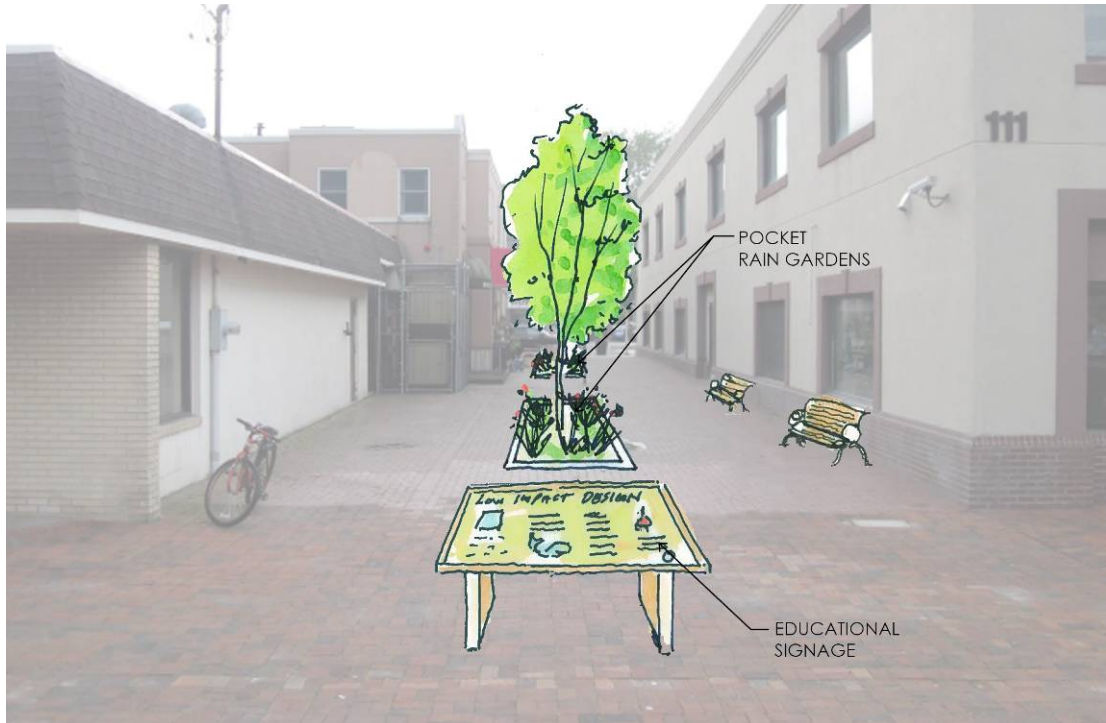
Figure 4-23. Proposed Pocket Gardens and Educational Signage

Pocket gardens in the alley. Pocket gardens could be installed along the brick walkway in the alley connecting the parking lot to South Street (*Figure 4-23*). These pocket gardens would be constructed as bioretention areas, although smaller and perhaps with a more formal planting structure. The gardens would receive runoff from the surrounding walkway and roof leaders. Benches and other landscaping amenities could be included in the design. Educational signage is also recommended at this highly-visible public location, which is located adjacent to the Friends of the Bay office, which could emphasize the connection between stormwater runoff and its impact on White's Creek (flowing below the parking lot) and the estuary complex.

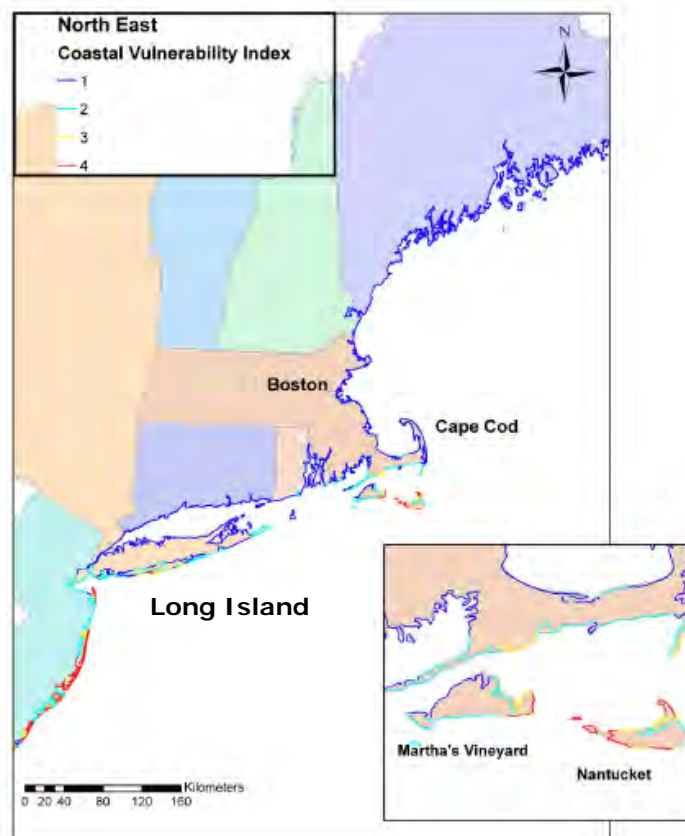
Areas of coastline most vulnerable to sea-level rise impacts have been identified by the U.S. Geological Survey (USGS) (Hammar-Klose and Thieler, 1999) through the calculation of a coastal vulnerability index (CVI). Calculation of the CVI depends on past changes in shoreline position, typical wave climates, tidal range, coastal geomorphology and sea-level history. Each region is assigned a CVI from 1 (low-risk) to 5 (high-risk). The assessment indicates a low CVI of 1 for the north shore of Long Island, in contrast to a CVI of 2 or higher for large segments of the south shore of Long Island and other coastal areas of the Northeastern U.S. (Figure 4-5). However, it is important to keep in mind that the CVI does not predict future shoreline location or take into account large events such as hurricanes.

Figure 4-5. Coastal Vulnerability Index (CVI) for the Northeastern U.S.

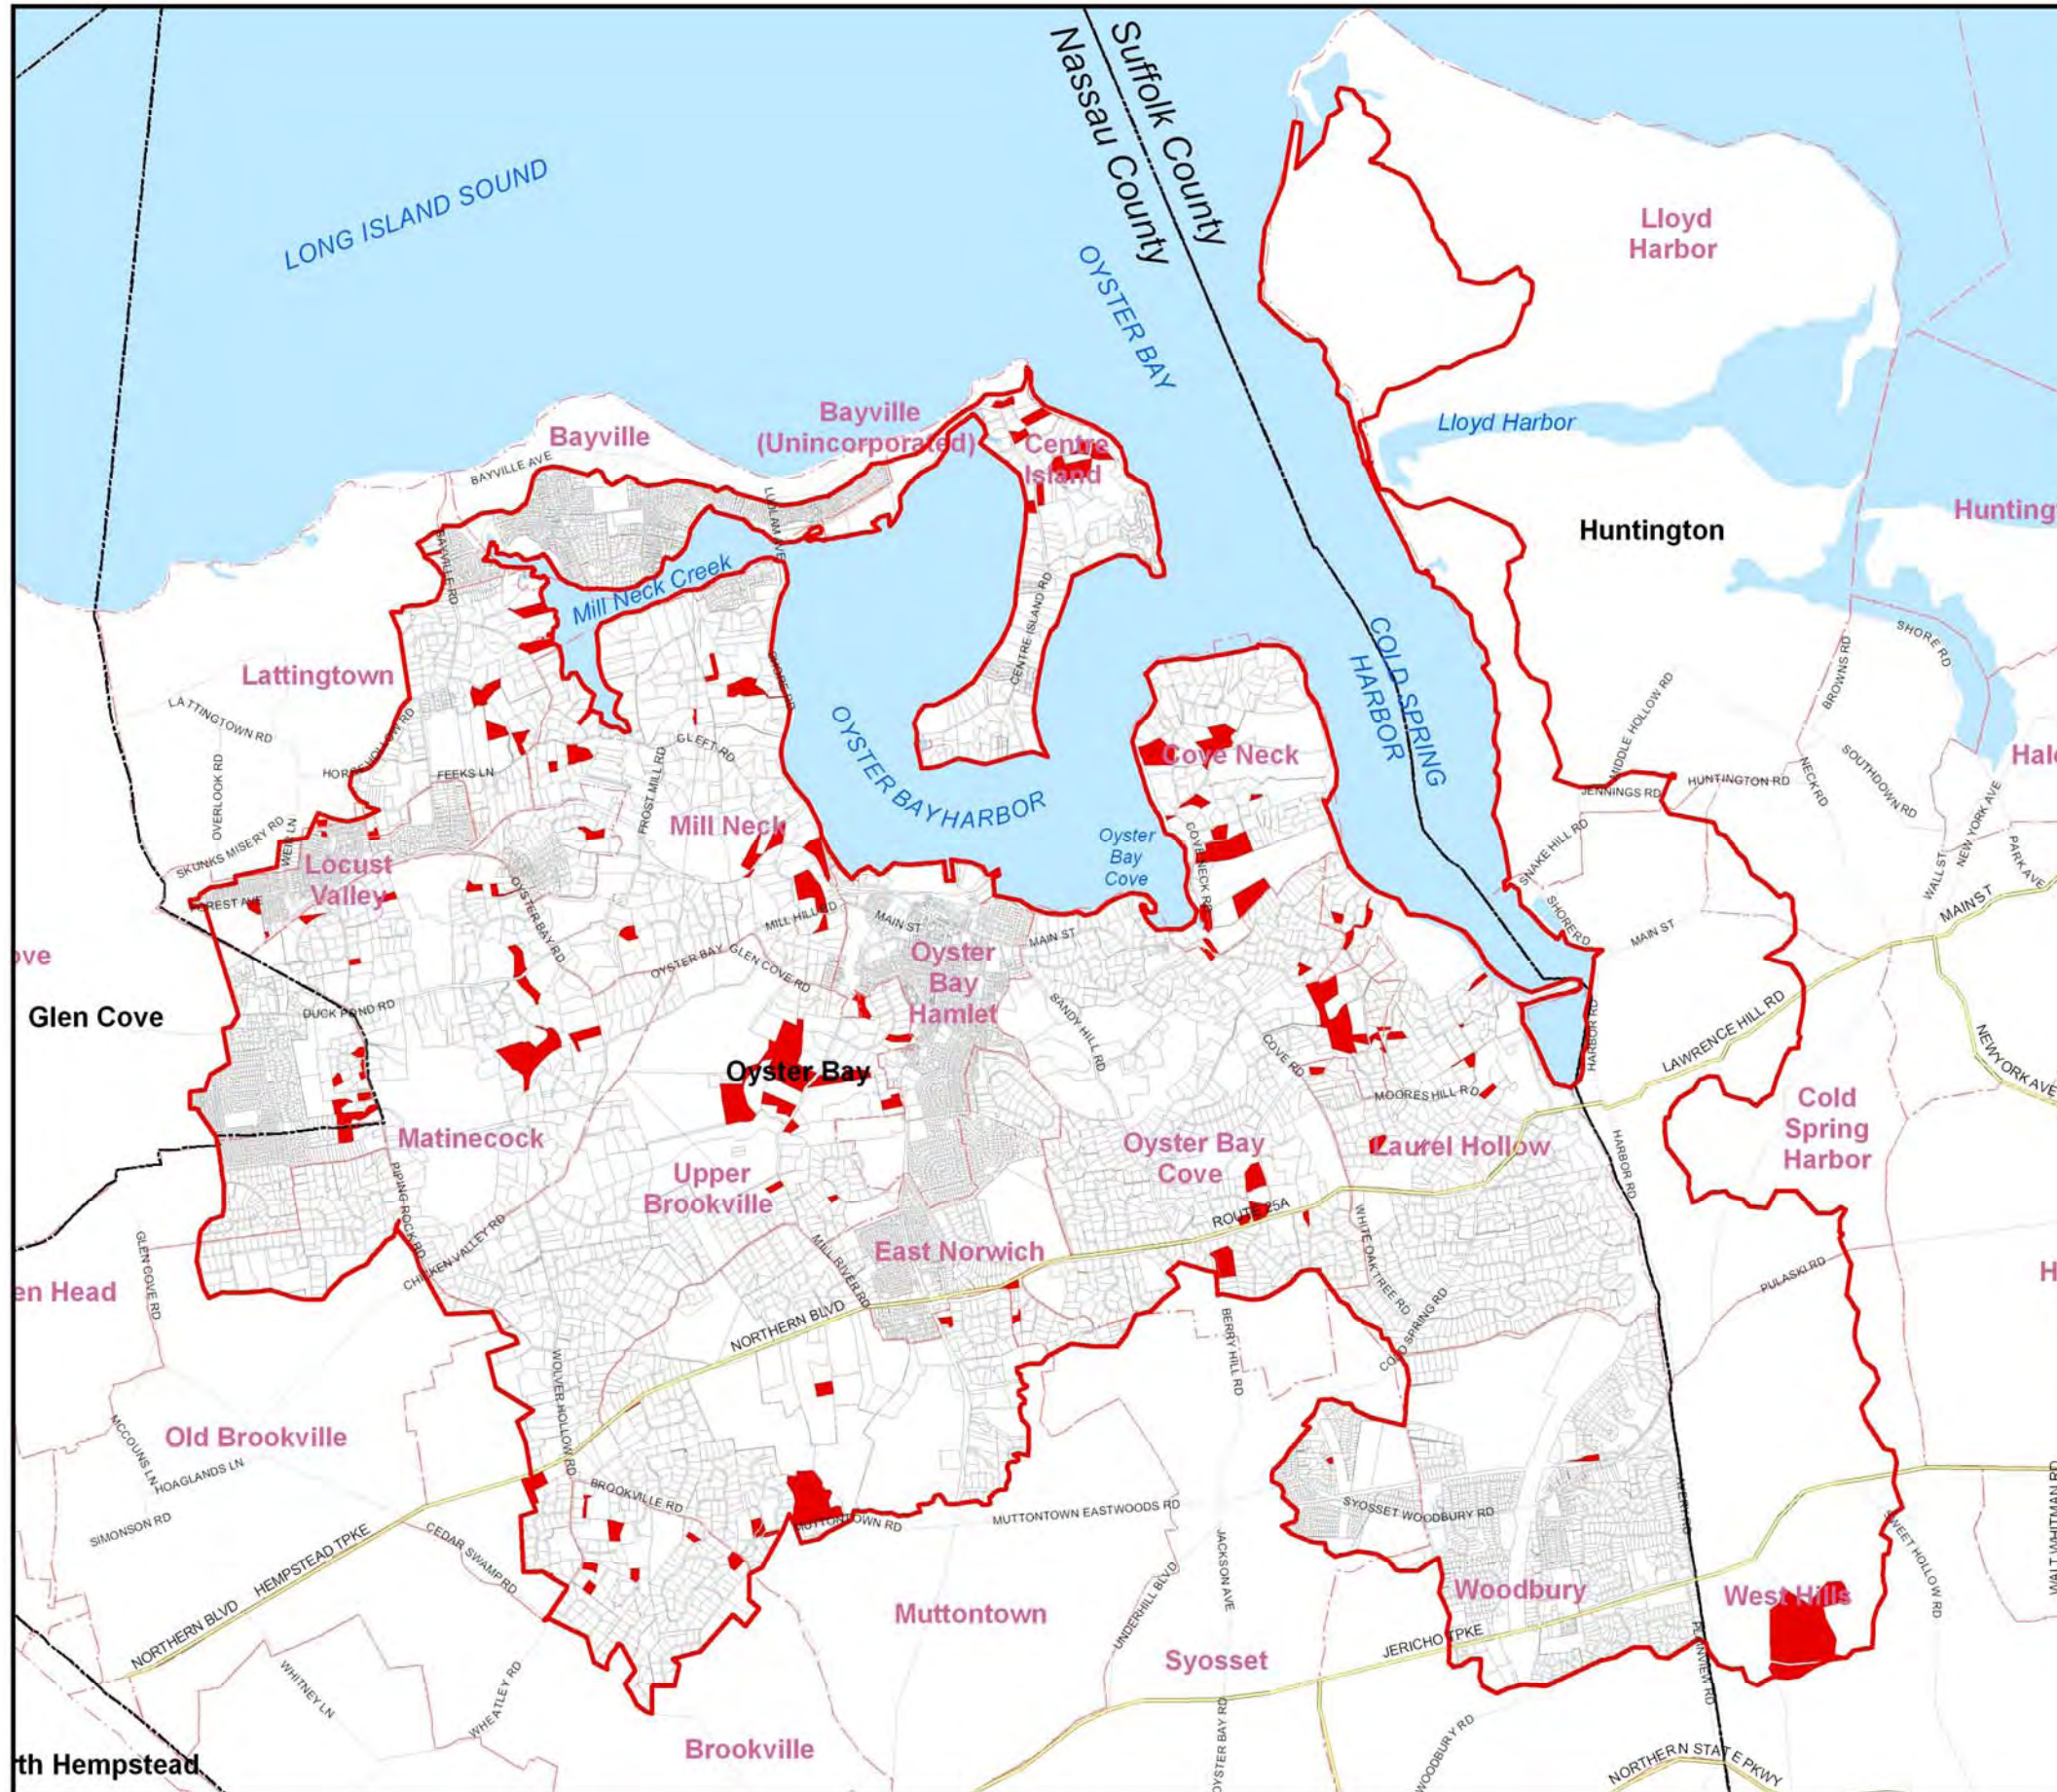
FIGURE 7-9
Potentially Developable Land

Existing undeveloped land that could be developed in the future (i.e. “developable” land) is shown in *Figure 7-9*. Land designated as “Potential New Development” in *Figure 7-9* includes parcels in the Town of Oyster Bay that are designated as “Vacant Land.” There is little vacant land remaining in the Town of Huntington, and no significant vacant parcels in the Huntington portion of the watershed. Areas identified as protected open space, as well as areas identified as having “Recreation and Entertainment” land use, were excluded from the analysis. Isolated fragments of land or parcels less than ¼-acre in size were also excluded. Potentially developable parcels were verified by Friends of the Bay using local knowledge of parcels that are unlikely to be developed and land designated as protected open space. The developable land in the watershed is primarily forested.

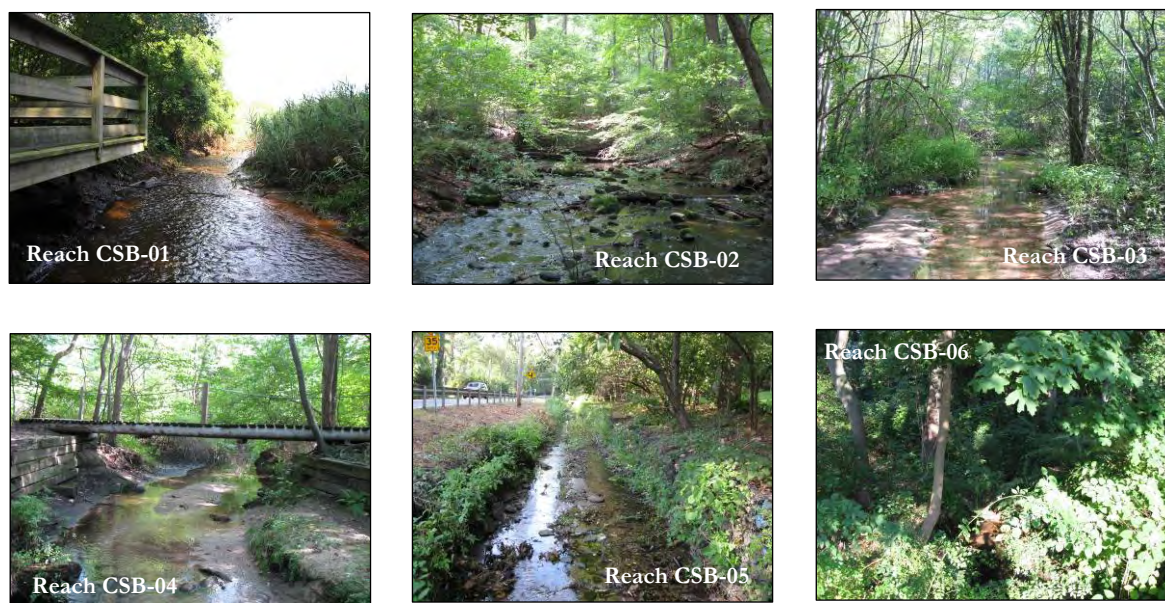
Figure 10-1. Photographs of Cold Spring Brook Stream Reaches

As depicted in the photographs in *Figure 10-1*, CSB-03 is the highest rated stream reach due to a wide vegetative buffer, adequate riparian cover, and good instream habitat. In contrast, CSB-05 has the lowest total score due to channel modification along the entire reach, the lack of canopy cover, poor instream habitat due to uniform channel properties, and limited stream buffer due to the proximity of Harbor Road.

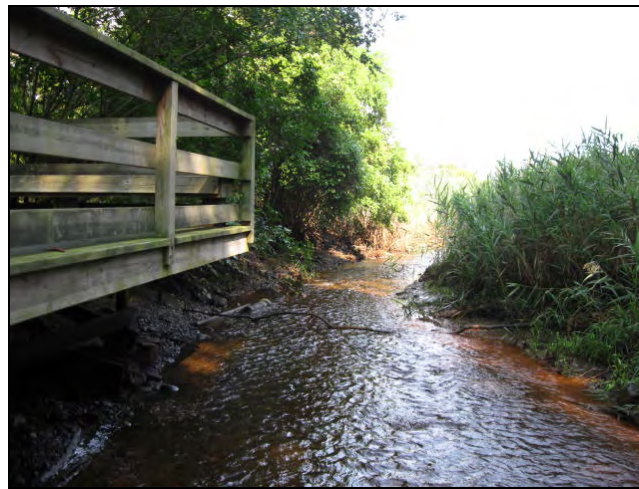
- IB – One area of impacted buffer is present on the left bank where a deck of approximately 15 feet in length was installed on the fish hatchery property. The deck was constructed to overhang the stream by approximately 2 to 4 feet.

Impacted buffer along reach CBS-01 near the Cold Spring Fish Hatchery property.

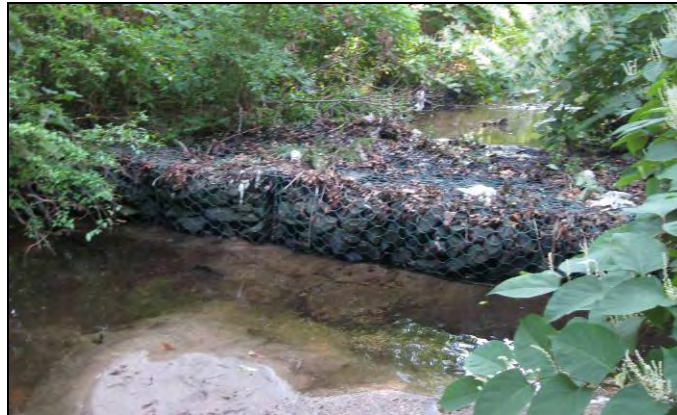
- SC – There is one stream crossing along reach SC-01, consisting of a gabion wall constructed across the stream channel at the upstream end of the reach. The gabion wall is approximately 2 feet tall, 6 feet long and 20 feet wide and spans the entire stream channel and banks. The gabion wall appears to have been constructed to prevent active headcutting at the location. Although the headcutting is no longer occurring, a pool exists downstream of the wall and shows signs of active downcutting.

Gabion wall along reach CSB-04

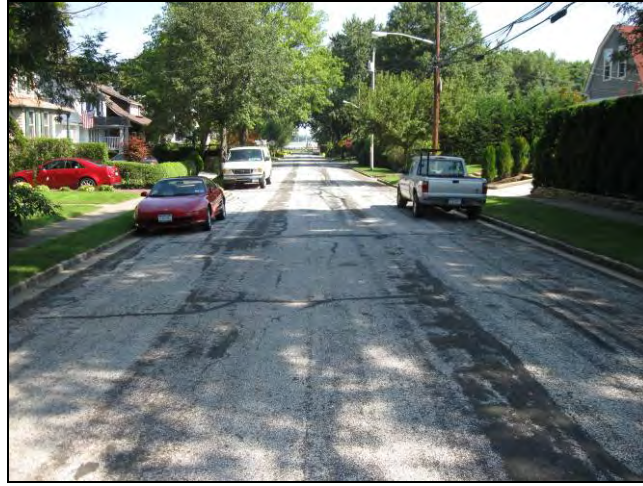
This neighborhood is a good candidate for “green streets” retrofits. The typical street width in this neighborhood is 28 feet and had low utilization of on-street parking observed mid-morning on a weekday. A potential restoration candidate for this location includes stormwater curb extensions that can be easily retrofitted alongside the existing curb. Runoff from the street could be conveyed to these landscaped infiltration areas and would overflow into the existing drain inlets during larger storms. Since this street has a lot of unused on-street parking, the addition of curb extensions would not adversely impact existing parking. The curb extensions could provide stormwater infiltration, a more aesthetically pleasing roadway, and traffic calming.

Views of Ships Point Lane residences, which is a potential candidate for a green streets retrofit.

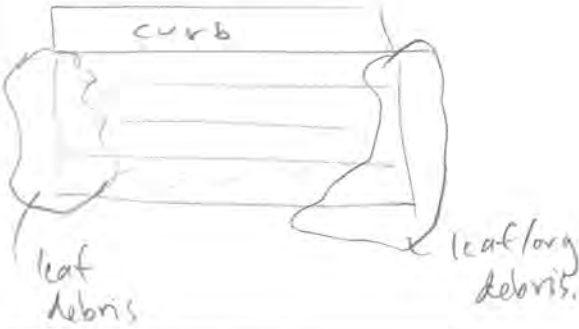
#1

CATCH BASIN SKETCHES
